Storms, Floods, and Debris Flows in Southern California and Arizona 1978 and 1980

**Proceedings of a Symposium
September 17-18, 1980**

Committee on Natural Disasters
Commission on Sociotechnical Systems
National Research Council

Environmental Quality Laboratory
California Institute of Technology

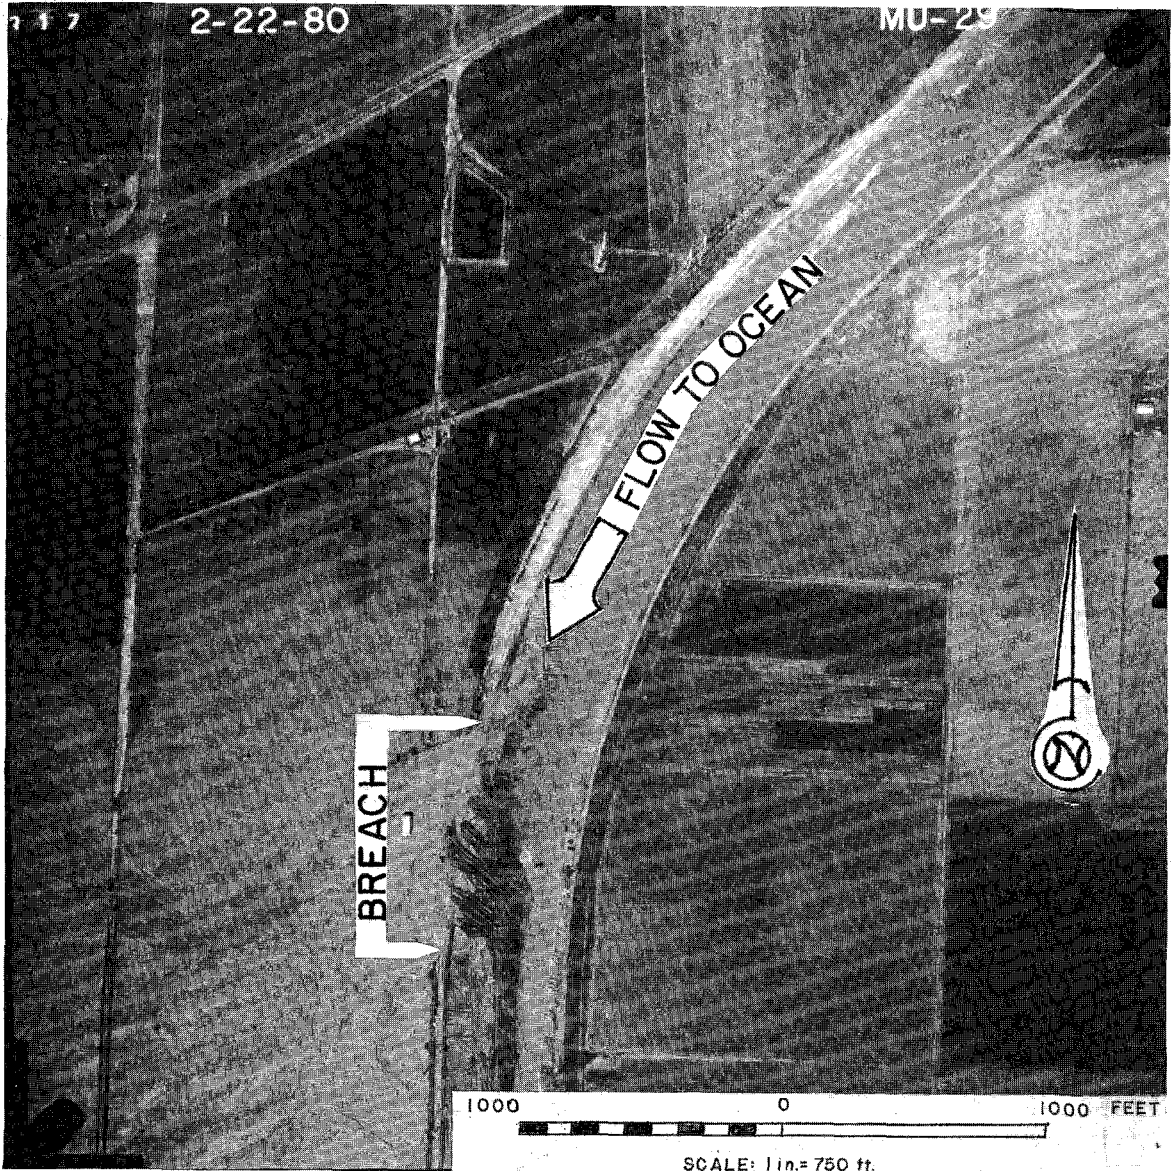
FIGURE 1 This aerial photograph shows the levee break on Calleguas Creek and construction crews trying to rechannel the escaping water. A total of 24,000 acre-ft of water flowed through the breach before it was repaired, and 450 acres of agricultural land were buried by silt from 4 in. to 4 ft deep. (Photograph by Western Aerial, February 22, 1980.)

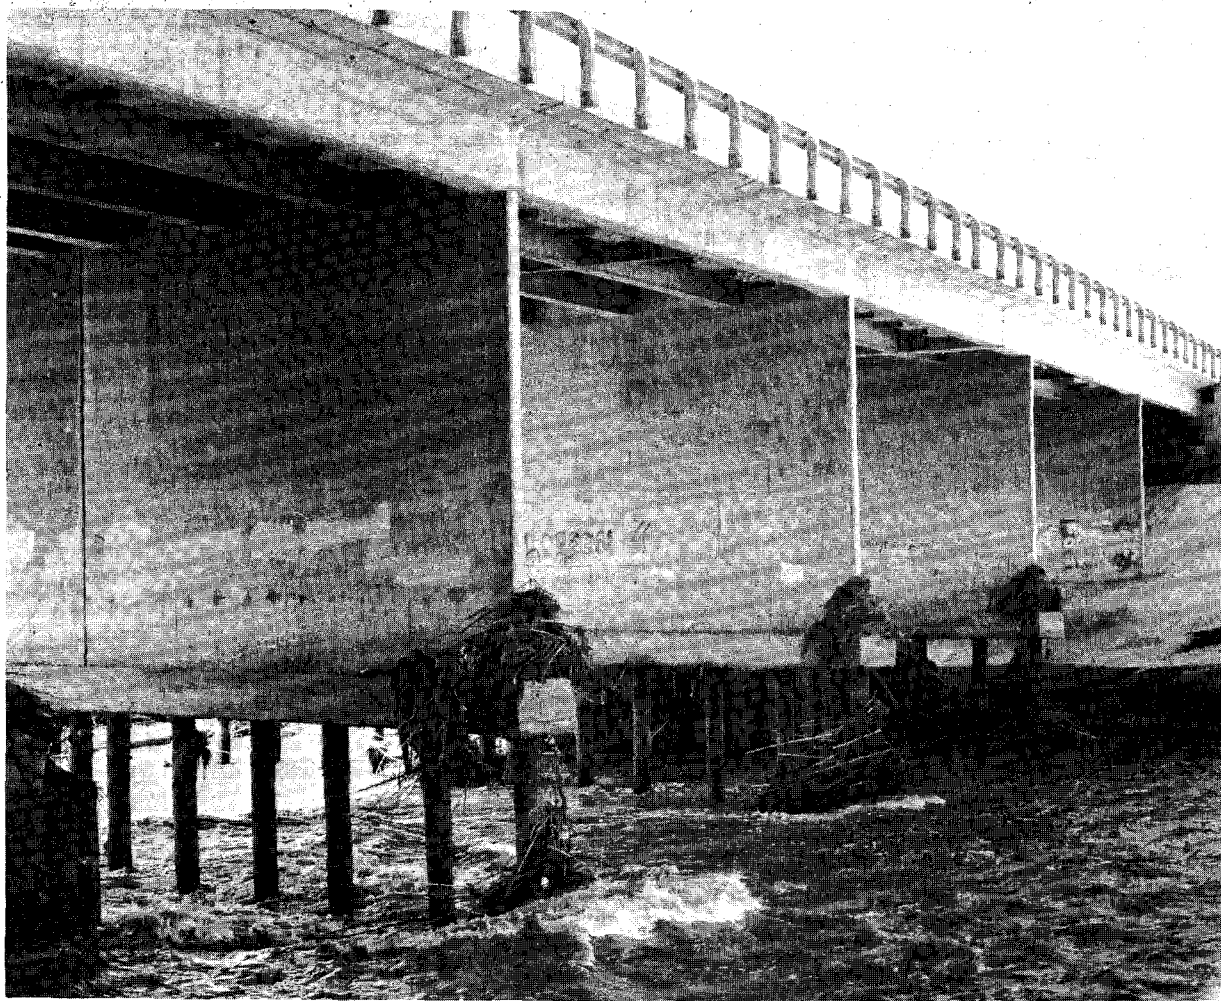
FIGURE 8 Scour of the bed of the Santa Ana River under the Fifth Street bridge in Santa Ana exposed the foundation pilings, as a result of the prolonged discharge of moderate flows from Prado Dam following the floods of February 1980.

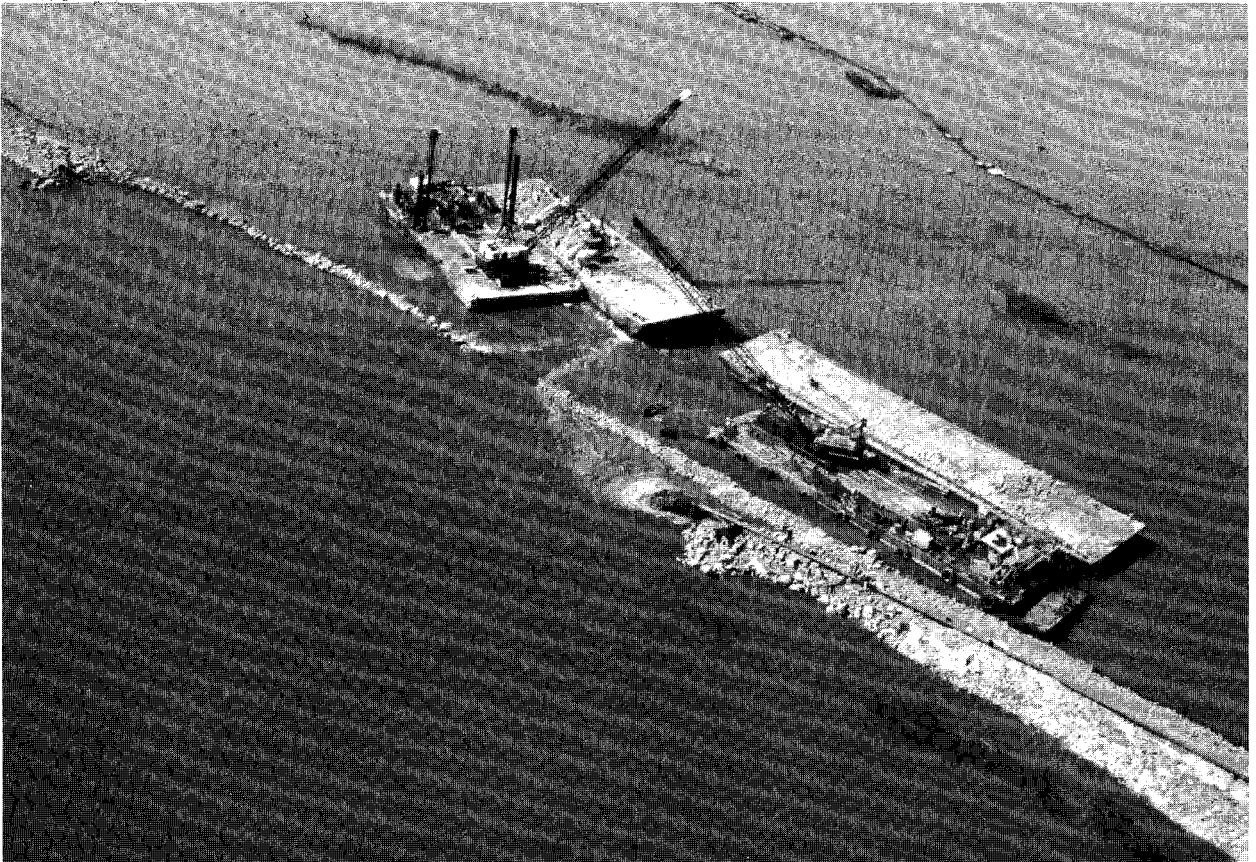
FIGURE 4 Sand and rock closure of Holland Tract.

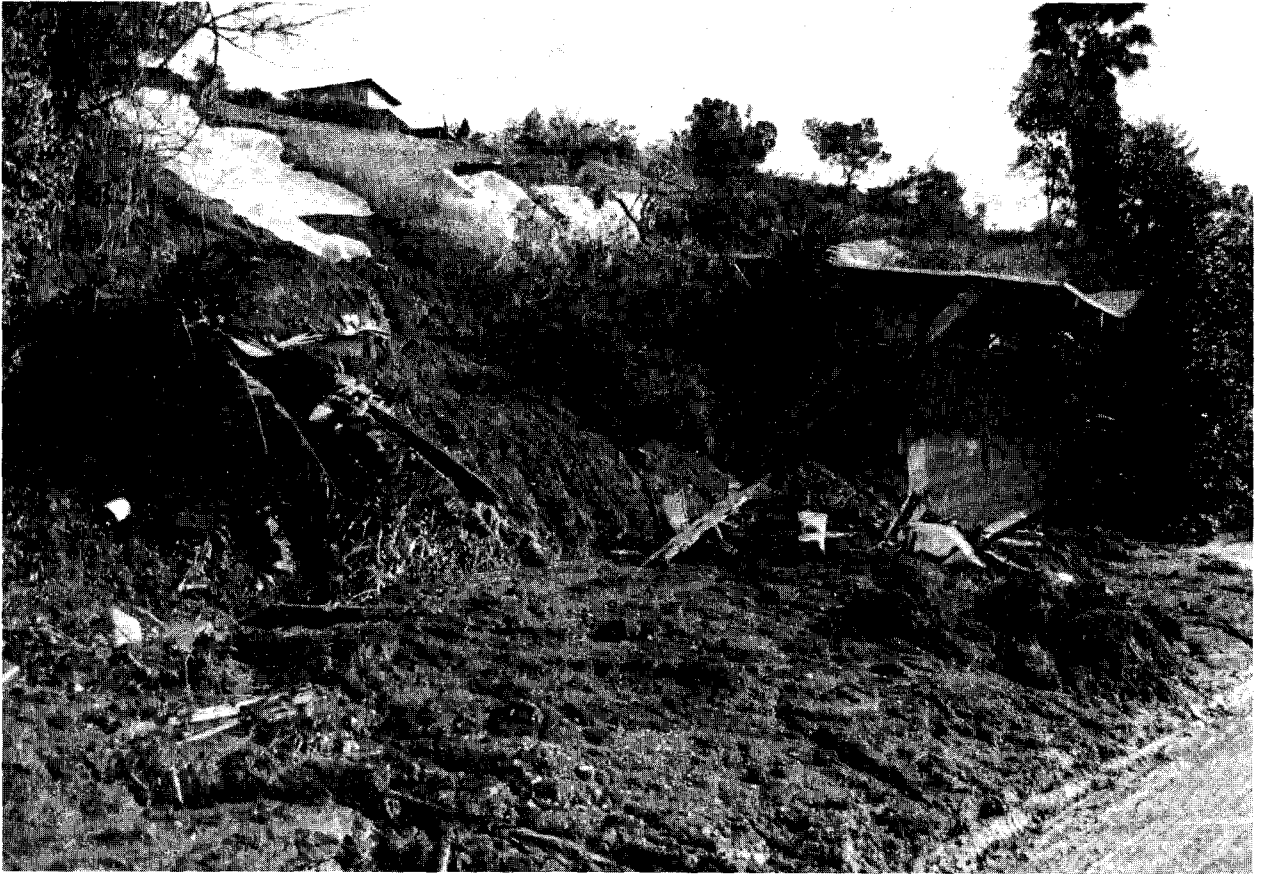
FIGURE 2 Photograph showing path of debris flow that seriously damaged the house at right on Divina Vista Street in Monterey Park.

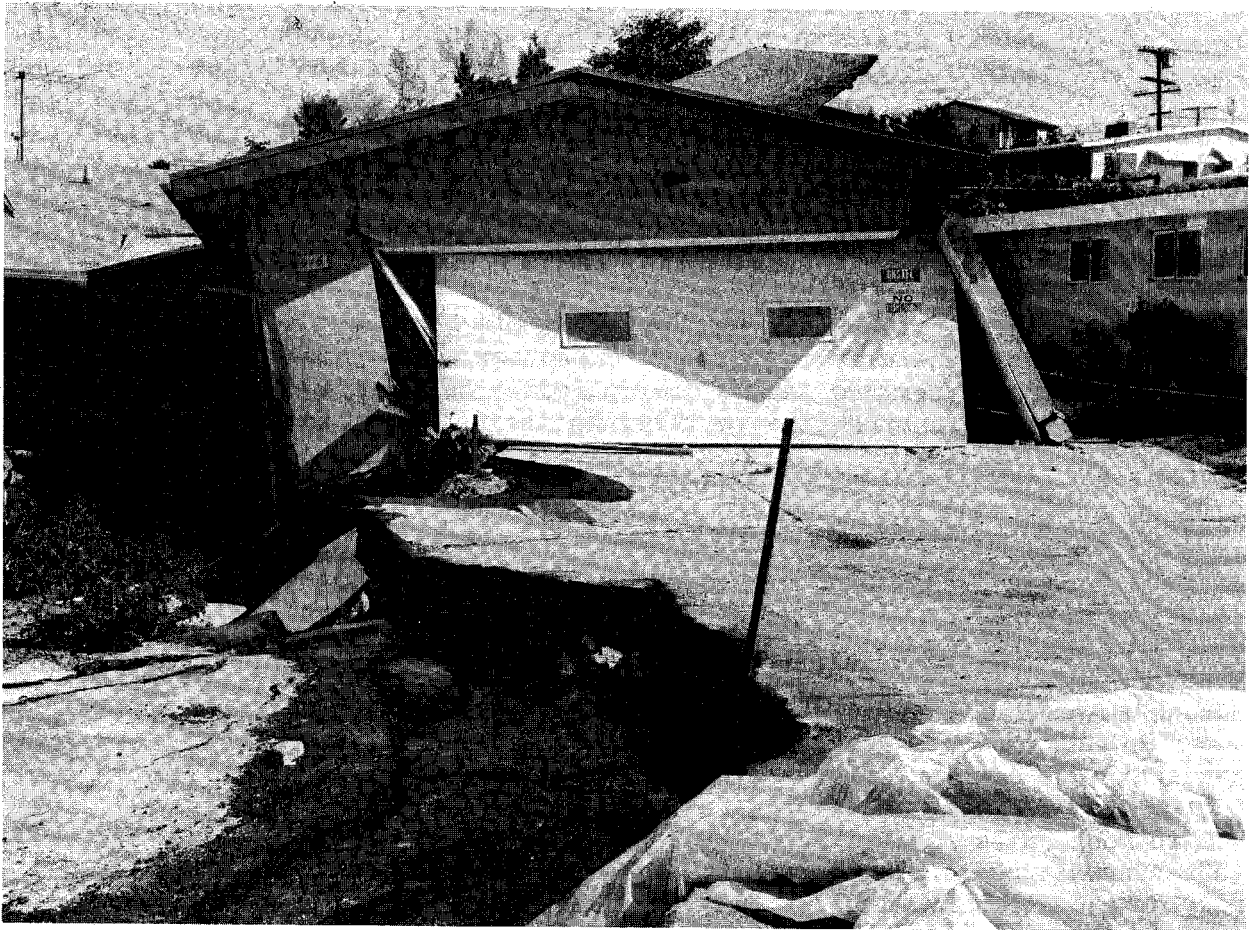
FIGURE 4 Damaging bedrock landslide that occurred in mid-April 1980 in the Mount Washington-Glassell Park section of the City of Los Angeles. The landslide probably resulted from the reactivation of an ancient bedrock landslide. (Photograph by John Shadle, Los Angeles City.)

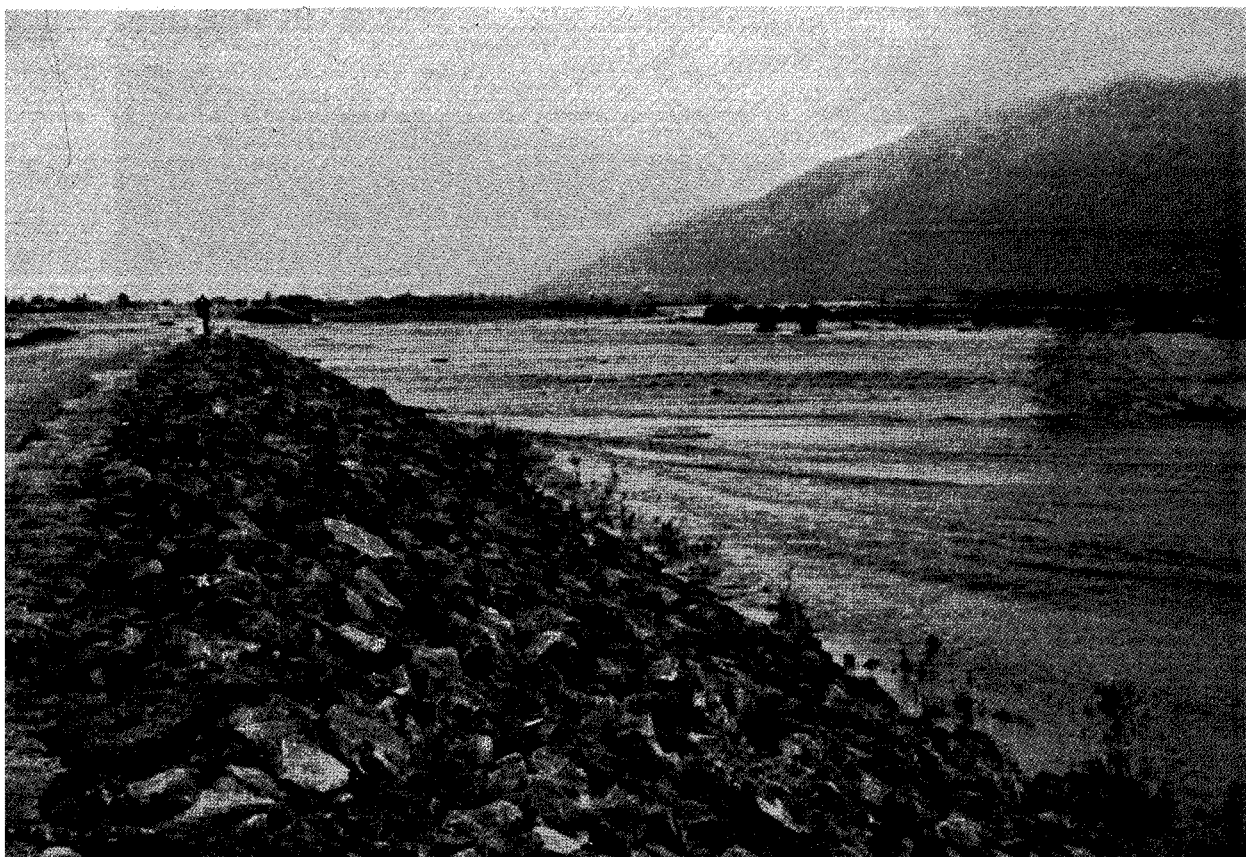
FIGURE 3 The San Jacinto River breach (looking downstream).

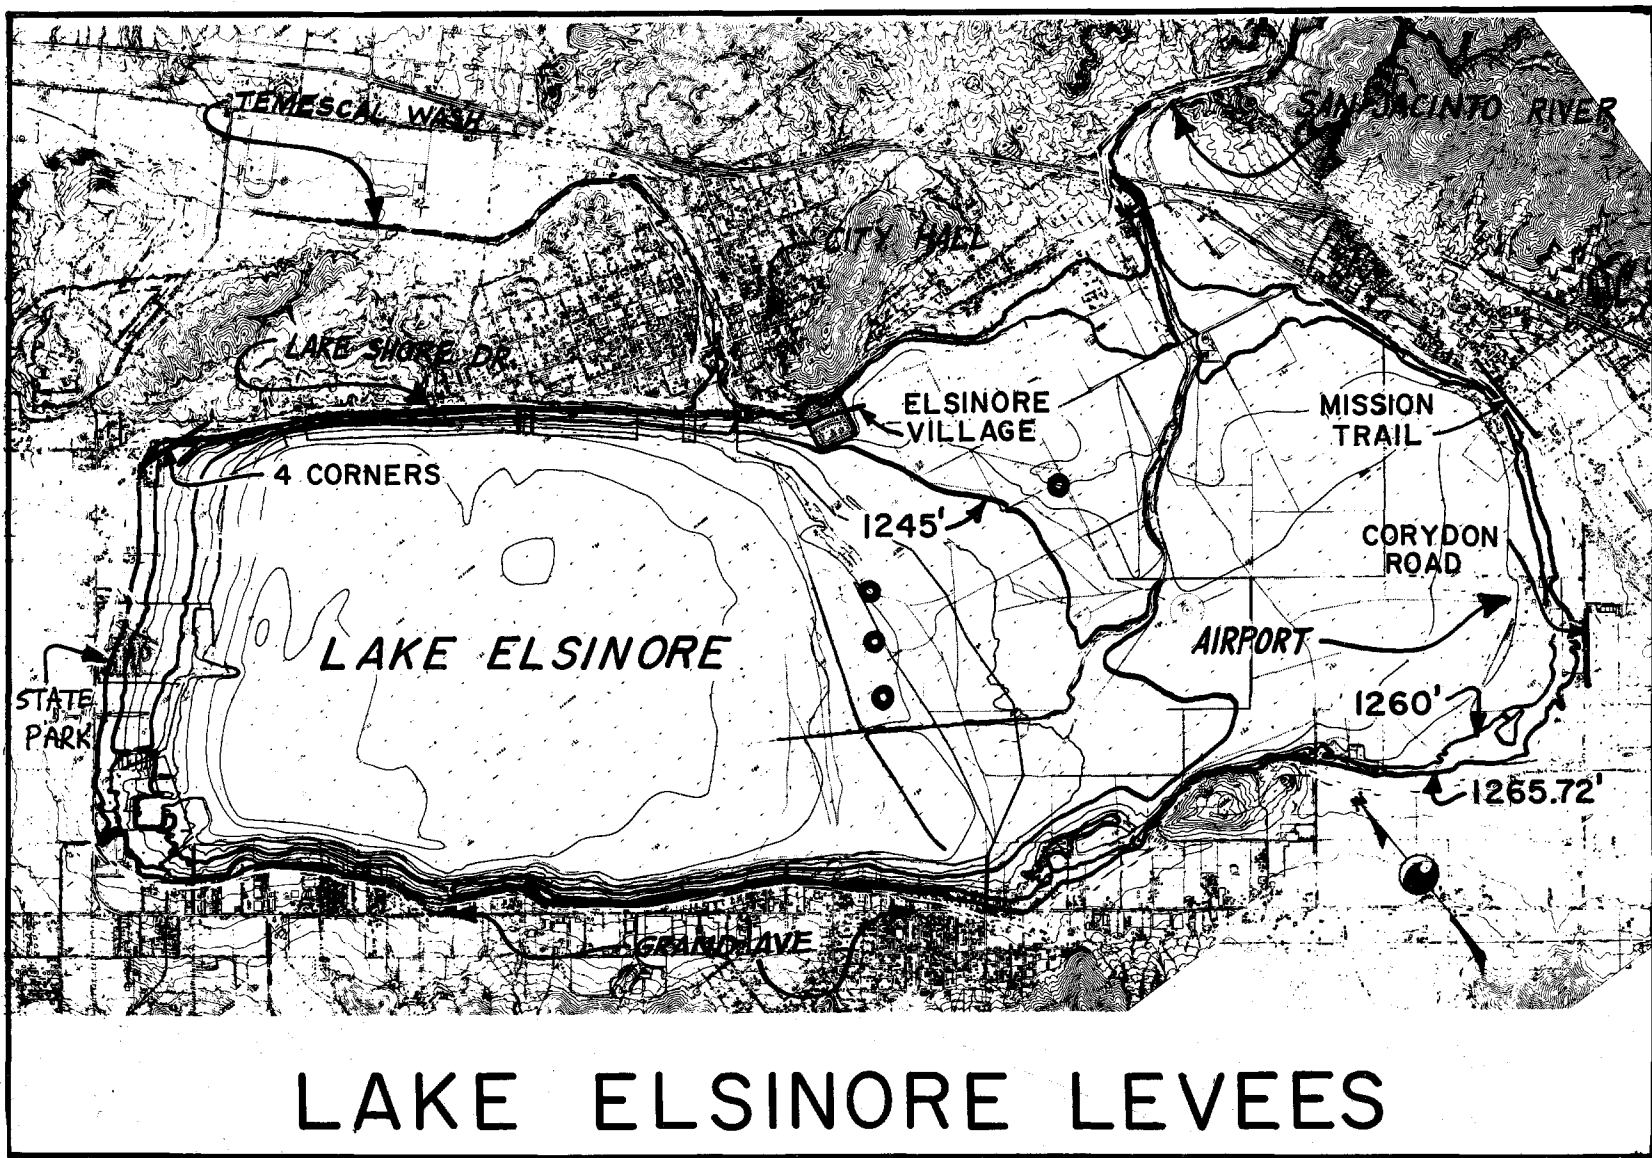
FIGURE 12 Lake Elsinore levees.

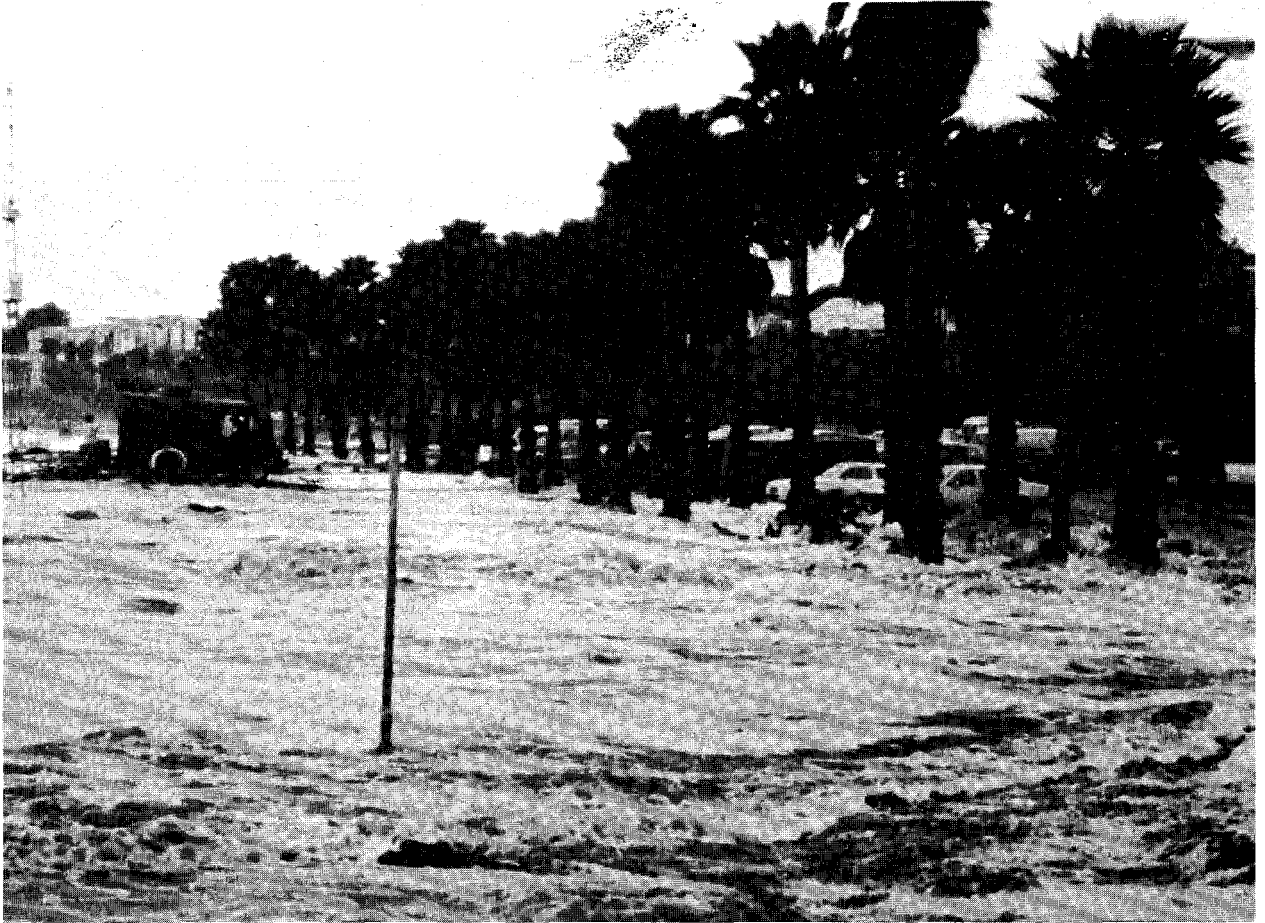
FIGURE 7 Inundation of the backshore of Leadbetter Beach at high tide on February 19, 1980. (Shore Processes Laboratory photograph.)

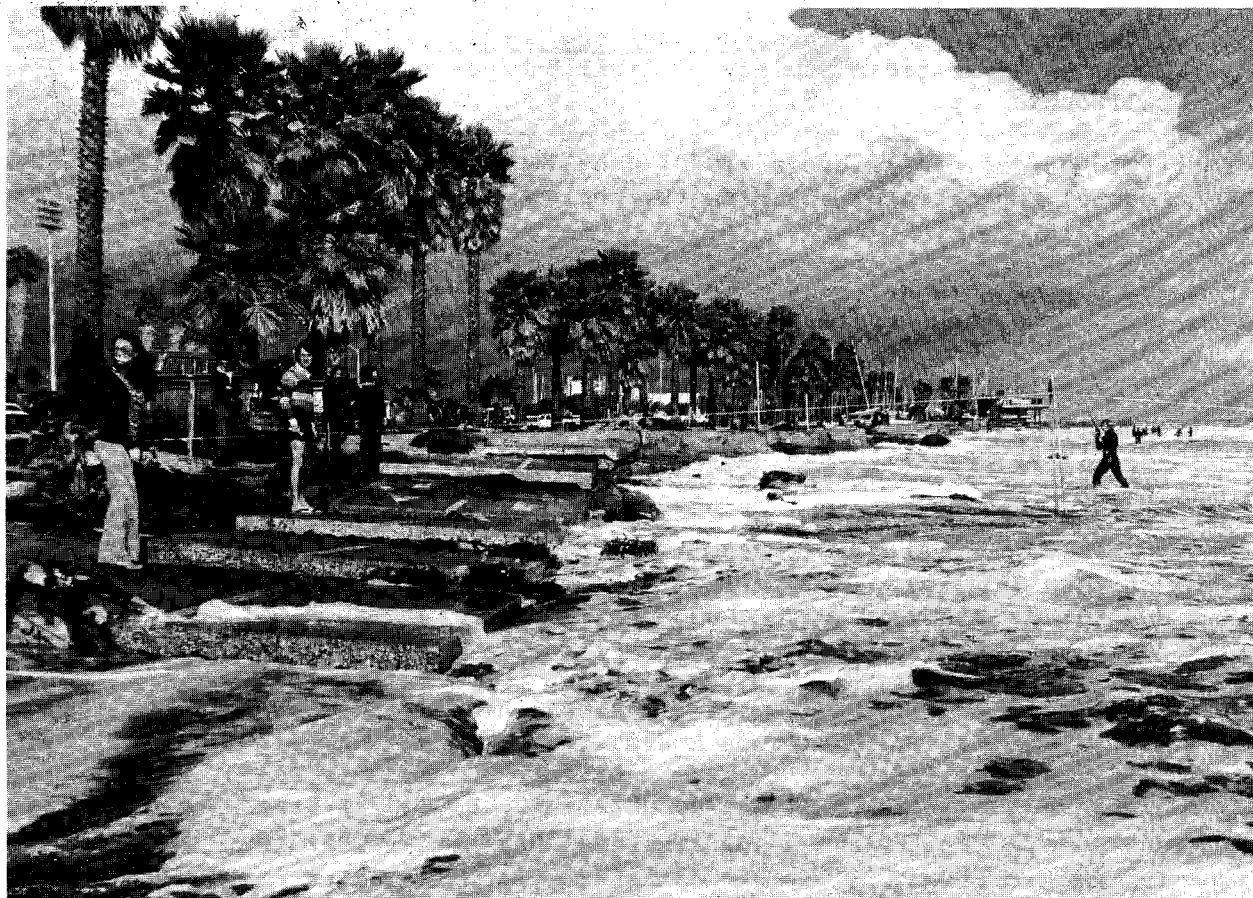
FIGURE 11 View of damage to Leadbetter Beach, February 23, 1980.
(Shore Processes Laboratory photograph.)
